Inspection-analysis Solution for High-quality and High-efficiency Device Manufacturing

OVERVIEW: The mass-production of a 90-nm node device and the development of a 65-nm node device were started in earnest in 2004. The manufacturing technology will be needed during the development of advanced devices to control and optimize the process condition and parameters by using the electrical characteristics during the development of advanced devices. Hitachi Group proposes inspection and analysis solution, ones that focus on in-line electrical characteristics monitoring. This solution consists of advanced inspection and analysis tools and application technology.

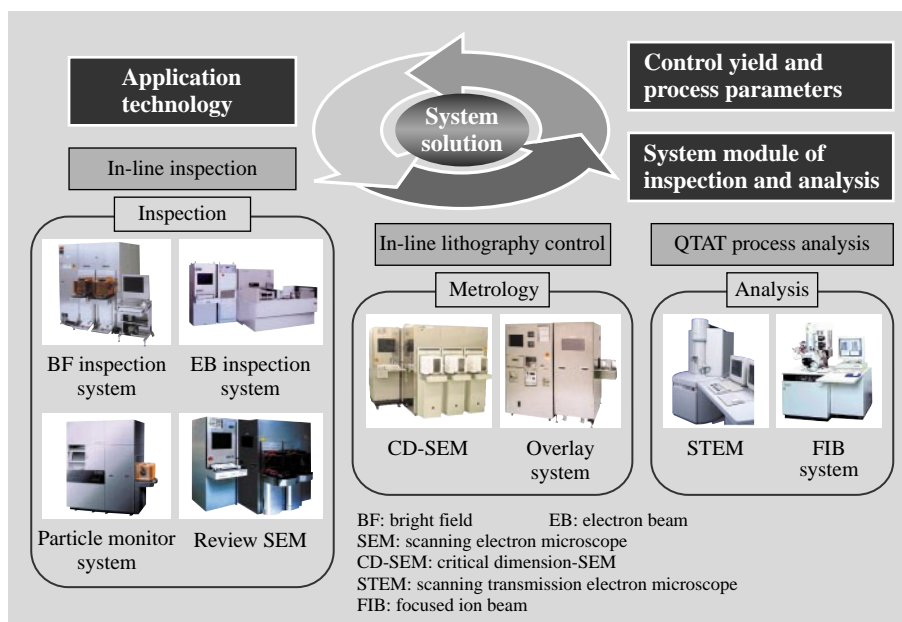
Fig. 1—Metrology, Inspection, and Analysis System Developed by Hitachi Group for Semiconductor Devices.

Hitachi Group has developed metrology, inspection, and analysis tools in addition to an inspection and analysis solution for high-quality and highly efficient semiconductor production.

To meet these needs, we have to establish a total inspection and analysis solution, focused specifically on electrical failures, such as contact failures and leakage defects, which directly affect the device electrical characteristics (see Fig. 1).

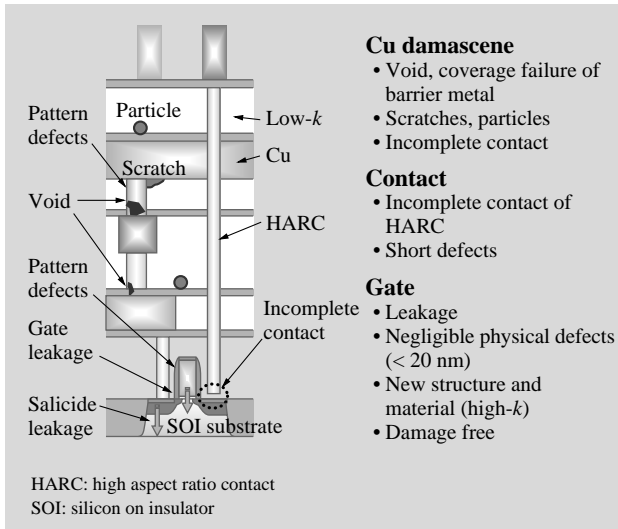
Fig. 2—Structure of Semiconductor Device and Defect Type at 65-nm Node.

Use of new material such as low-*k*, high-*k* is begun.

Performance requirements (high speed, low power) are increased.

Fig. 2 shows the device structure of a 65-nm node

A multi-structure gate in the front end of 65-nm nodes and beyond was developed for high-speed and high-performance devices. Strained silicon and SOI were applied as part of a new process technique to control punch through, to reduce leakage current, and to allow for low power. Also, a high-*k* material was applied as gate dielectrics for the reliability of gate characteristics. In the back end of the devices, multi-layered Cu wiring of a dual damascene structure was introduced, and low-*k* material was applied as wiring dielectrics. Because of the multi-layered wiring process and damascene structure, the number of via holes was increased, and the yield impact by the via hole process was increased⁽¹⁾.

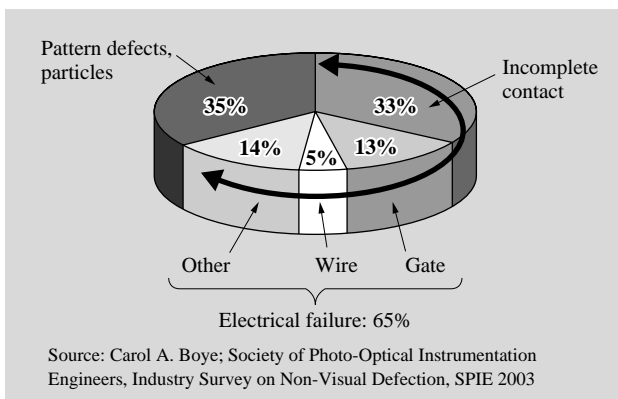
Fig. 3—Ratio of Electrical Failure within Defects. Analysis of cause of low yield by SEMATECH Inc. showed ratio of electrical failure have been more than 65%.

A highly accurate measurement of every CD and structure evolving along with process shrinkage is required, and on top of this, measurement/inspection of electrical characteristics and process results of a whole wafer are also required. Fig. 3 shows an example of classification of probe testing failures. The electrical failures caused by contact and wiring process failures was more than 60%. This result shows that the contact failures and wiring process inspection are very important to yield enhancement⁽²⁾.

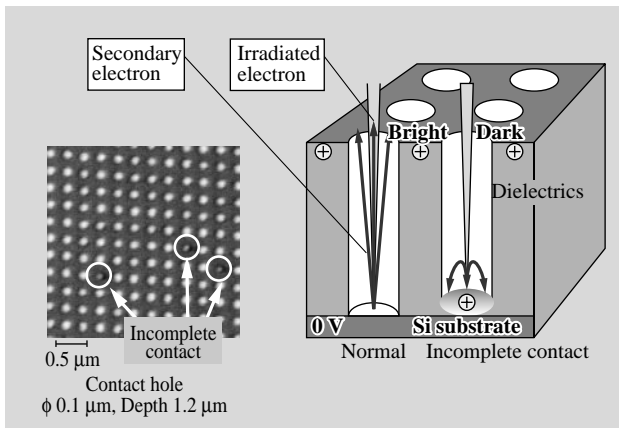
Fig. 4—Voltage Contrast Principle and SEM Image of Incomplete Contact.

With positive voltage contrast mode, contrast of normally opened contact hole is bright and contrast of incomplete contact hole is dark. It is because the number of secondary electrons reaching detector is changed by the charging condition at the bottom of hole.

The EB inspection tool is effective to detect a hidden electrical failure such as an incomplete contact, short wiring defect, and voids. The principle of EB inspection is as follows; a large current EB is irradiated to a semiconductor wafer surface, and secondary electrons are detected. The number of secondary electrons, which are emitted to the detector, is affected by surface charging voltage. Using this phenomena, the electrical condition inside the device can be detected by the contrast in the SEM image (detection of voltage contrast)⁽³⁾. Fig. 4 shows these principles. For example, when the EB is irradiated at an incomplete contact, the charging voltage of this incomplete contact increases over that with the normally opened contact hole. Because of this charging condition difference, the number of secondary electrons, which are emitted from the bottom of the hole, is different between the normally opened hole and the incomplete hole. For a positive charging condition, the normally opened hole is observed as bright contrast, and the incomplete hole is observed

as dark contrast. Not only contact failures but also short defects, leakage, broken wire, resistance failures, and capacitance failures can be detected using these voltage contrast phenomena.

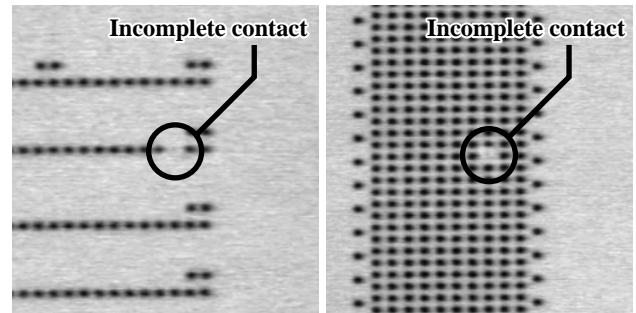
Fig. 5—Example of Application of EB Inspection to Contact Layer at Peripheral Pattern of DRAM Products.

Incomplete contact failures of the holes of aspect ratio 10 are detected stably.

Fig. 5 shows an example of applying EB inspection to via holes inspection at the peripheral pattern of advanced DRAM (dynamic random access memory) production. Incomplete contact failures at the layer of aspect ratio 10 were detected from this example. These results show that EB inspection is effective as a contact

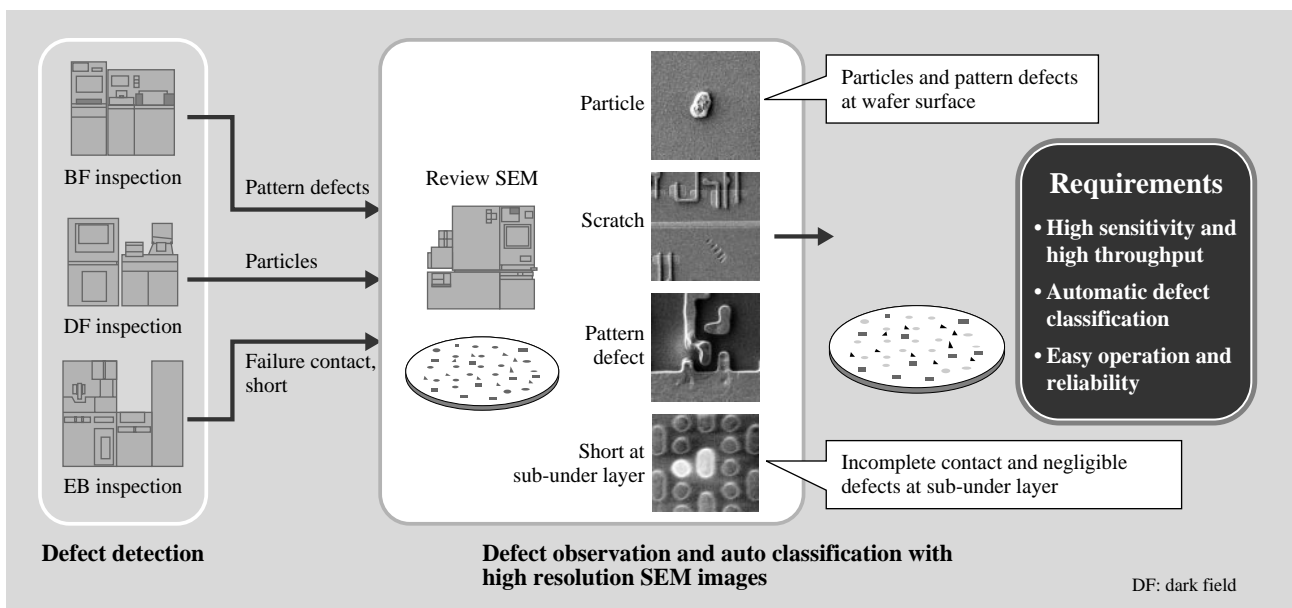
Fig. 6—In-line Defect Classification Station; Review SEM.

Review SEM classifies particles, pattern defects and electrical failure, and extracts killer defects from the larger number of the defects detected by various inspection tools.

Review SEM is an effective tool to observe the defects which are detected by other tools with high-resolution images and to classify the types of them. Because various kinds of defects occur during the development stage of new production, we need to extract the serious defects efficiently and to review them quickly. As shown in Fig. 6, the review SEM must review and classify the particles, pattern defects, and electrical failures, and identify the killer defects from the defects that are detected by the various inspection tools such as EB inspection, BF inspection, and a particle monitor.

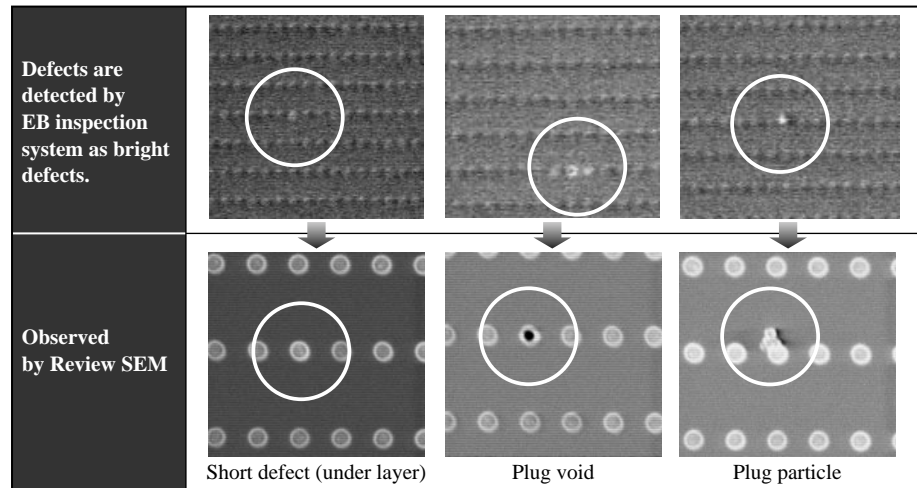
Fig. 7—Review SEM Image of Detected Defects Using EB Inspection as Brighter Defect Compared with Normal Bit. Detailed information of defects is obtained by high resolution SEM images.

Fig. 7 shows the review SEM images of the defects

detected with the EB inspection tool at a brighter contrast than the normal bit. The first type of defect is a short defect of the under layer. The second type is a small particle in a plug pattern. The third is a void of the plug. These images indicate that a high-resolution image is necessary to classify the type of defect accurately.

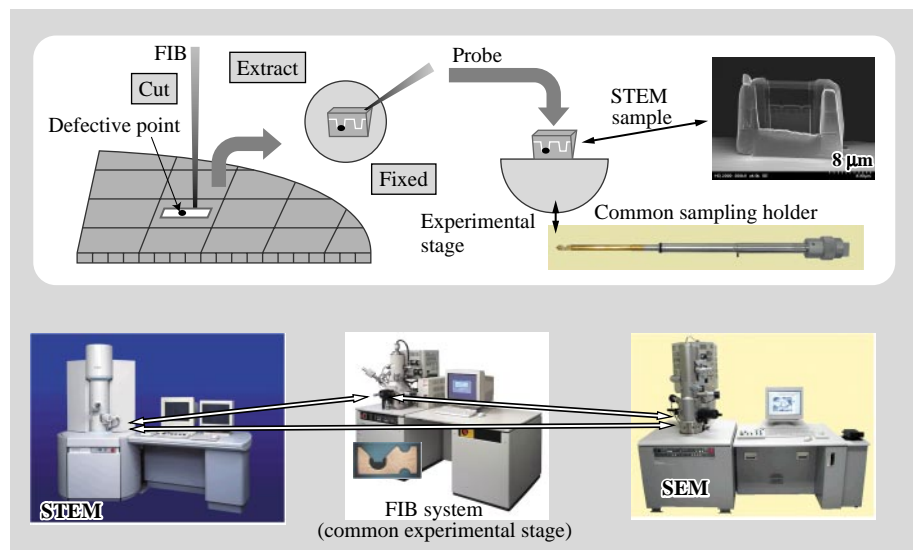
Fig. 8—Hitachi Group's Failure Analysis System. Defect point is sampled by micro-sampling technique of Hitachi FIB and observed by STEM and high resolution SEM.

The defect root cause analysis of hidden electrical failures requires a cross-sectional observation by high-resolution SEM and STEM. During the failure analysis, a Hitachi micro-sampling method (see Fig. 8) was useful to cut the defective part of the sample out of the wafer. Several ways are used depending on the defect type^{(6), (7)}.

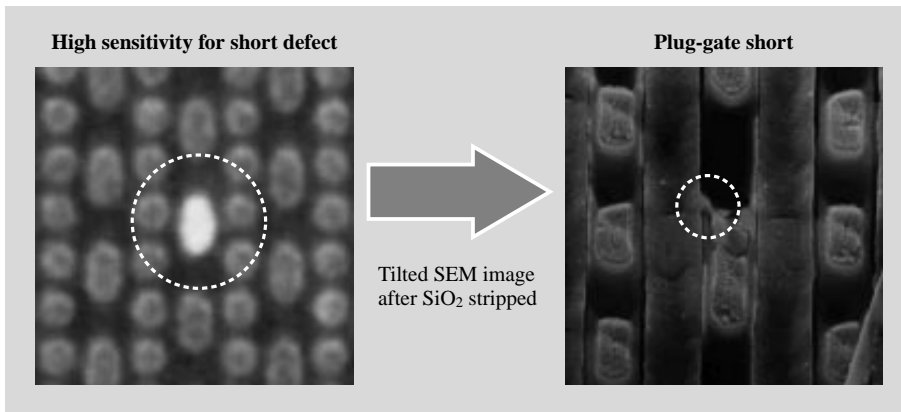
Fig. 9—Application Example of Review SEM Observation of Defect Detected by EB Inspection. Short defects between plug and gate have been observed after stripping surface oxide film.

of this layer was short defects. The brighter plugs compared with the normal bit were detected by this in-line EB inspection. These defects were classified as electrical failures by Hitachi review SEM. The top oxide layer was stripped off based on this information, and defects were found to be plug-gate short (see Fig. 9)⁽⁸⁾.

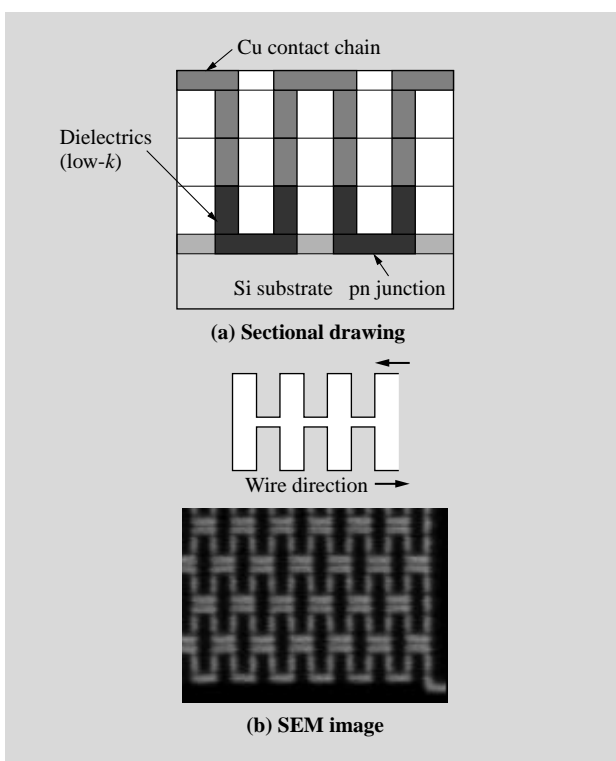
Fig. 10—Structure of Cu Contact Chain Test Pattern. Test pattern structure is arranged using highly dense contact chain.

The second application is the Cu wiring test pattern inspection. The DOI of this inspection is the Cu void. Fig. 10 shows the test pattern structure. The contact chain pattern was inspected. The point of contrast change was detected inside the contact chain pattern using Hitachi's EB inspection tool. The *I-V* characteristics between both ends of the wiring of the wiring defect point were evaluated. Fig. 11 shows the result of the *I-V* characteristics. At the high contrast point, the resistance of Cu wire was higher compared with the normal point. However, the resistance of some of the defects point was reduced rapidly, and the voltage contrast became the same as normal wire, when the voltage applied to the both ends of the defect point was raised above 2–3 V. This result indicates that we need to control charge voltage to detect the high resistance defects with high sensitivity. These defects

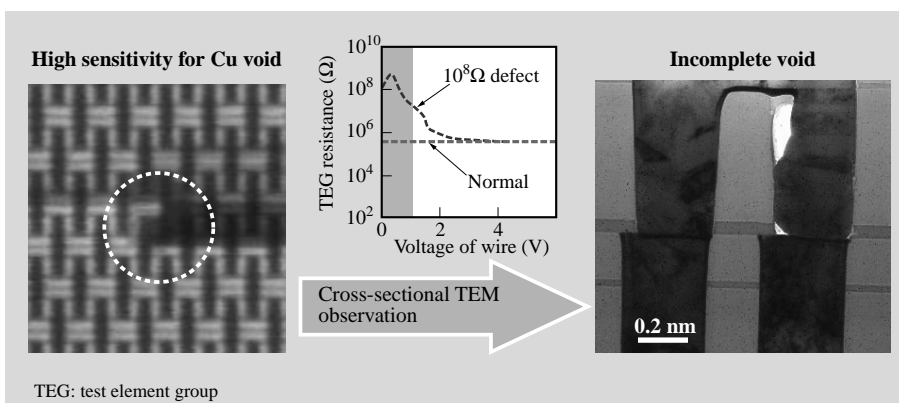
Fig. 11—Analytical Result of Defects inside Contact Chain. Result is shown of electrical characteristics analysis and cross-sectional observation for Cu void.

were analyzed by a cross sectional STEM observation using micro sampling by our FIB inspection system. These defects were the coverage failures of the barrier metal (see Fig. 11).
